Intel[®] Pentium[®] III Xeon[™] Processor Specification Update

Release Date: August 2001

Order Number: 244460-030

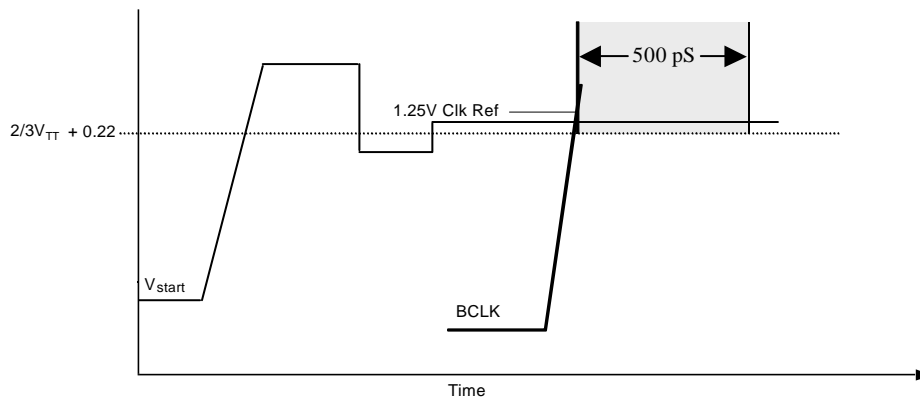
Intel has characterized the new AGTL+ AC specification for $V_{IH(MIN)}$ on the processor's RS0# signal to be: $(2/3 \cdot V_{TT}) + 0.22$ Volts within 500 picoseconds following the rising edge of BCLK crossing the 1.25-Volt threshold. See below.

Implication: The deviation from the published specification results in decreased noise margin on the RS0# processor input. This decreased noise margin has been observed to be particularly detrimental in system environments where the RS0# processor input is being driven by an I/O buffer with a pull-up device (such as a p-channel transistor) that is switched off mid-cycle. Systems that employ I/O buffers that keep the pull-up device on for the entire cycle are significantly less affected by this erratum. The reduction in noise margin may lead to the generation of BINIT# (when enabled) resulting in a system reset, otherwise this condition may lead to a system "hang" condition.

Workaround: If a system design cannot meet the specification deviation, the following areas should be carefully examined to assure that additional margin exists in order to compensate for any deficit observed with respect to the newly characterized $V_{IH(MIN)}$ specification:

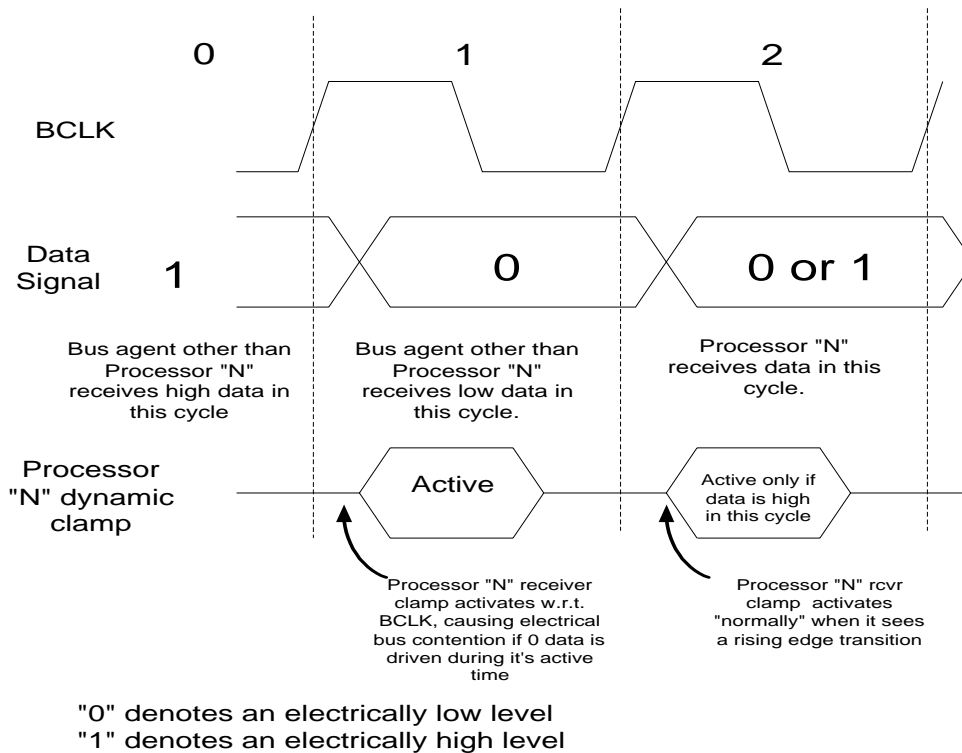
Problem: Falling edge ledge push-out and undershoot may be seen on AGTL+ data and data bus ECC signals. The AGTL+ receiver's dynamic clamp circuit activates (i.e. clamps the signal to an electrically high level) in certain cycles when data is driven to an electrically low level by another agent.

Implication: This erratum only occurs on a processor that does not receive data in that particular cycle. More specifically, this erratum only occurs when a specific processor does not receive data in the current BCLK period, but receives data in the very next period. Therefore, the processor inducing this falling edge noise (on data and data bus ECC signals) will not actually read the data in that cycle. See below for an illustration of this erratum affecting a processor denoted Processor "N". The falling edge ledges and undershoots may affect the signal quality and/or timing at agents that receive data in that cycle. Therefore, the impact of this erratum is highly dependent on system bus design.

Workaround: Evaluate system bus signal quality and timing margin at the valid receiving agent as a result of this falling edge noise. Due to dependence upon system bus design, bus layout may be evaluated to determine the need for improvements in signal quality and timing margin at the valid receiving agent as a result of this receiver-induced falling edge noise.
